# Construction Cost Case Study

## Parking Structure, Cincinnati, OH

Size: 4 Levels, 175,000 SFG, 450 Spaces  
 Site: 1.2 acres  
 Labor: Union  
 Delivery: General Contractor under GMP Contract  
 Schedule: 11 months

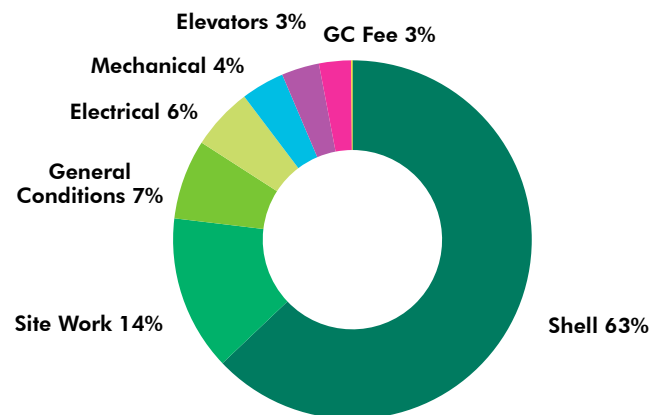
### COST DISTRIBUTION

TRADE	ROUNDED COST	COST/SF	COST/SPACE
Site work	\$1,661,000	\$9.49	\$3,691
Concrete	6,600,000	37.71	14,667
Masonry	96,000	0.55	213
Metals	135,000	0.77	300
Thermal/Moisture Protection	543,000	3.10	1,207
Doors	15,000	0.09	33
Finishes	18,000	0.10	40
Specialties	130,000	0.74	289
Elevators	400,000	2.29	889
Fire Protection	127,000	0.73	282
Plumbing	188,000	1.07	418
HVAC	155,000	0.89	344
Electrical	674,000	3.85	1,498
<b>Subtotal</b>	<b>\$10,742,00</b>	<b>\$61.38</b>	<b>\$23,871</b>
General Conditions	\$860,000	\$4.91	\$1,910
GC Fee	322,000	1.84	716
<b>Total Hard Cost</b>	<b>\$11,924,000</b>	<b>\$68.13</b>	<b>\$26,497</b>
